**VILLAGE OF HUNTINGTON BAY
HUNTINGTON HARBOR
RETROFIT PROGRAM PLAN REPORT
Permit # NYR 20A292**

**Prepared for:
NYSDEC
Division of Water Permits 4th Floor
625 Broadway, Albany New York 12233**

**Prepared by:
Jeffrey P. Vollmuth, P.E., Village Engineer
VOLLMUTH & BRUSH
200 Blue Point Avenue
Blue Point, New York 11715
(631) 363-2683
(631) 363-2062 FAX
jeff@vollbrush.com**

September 26, 2014

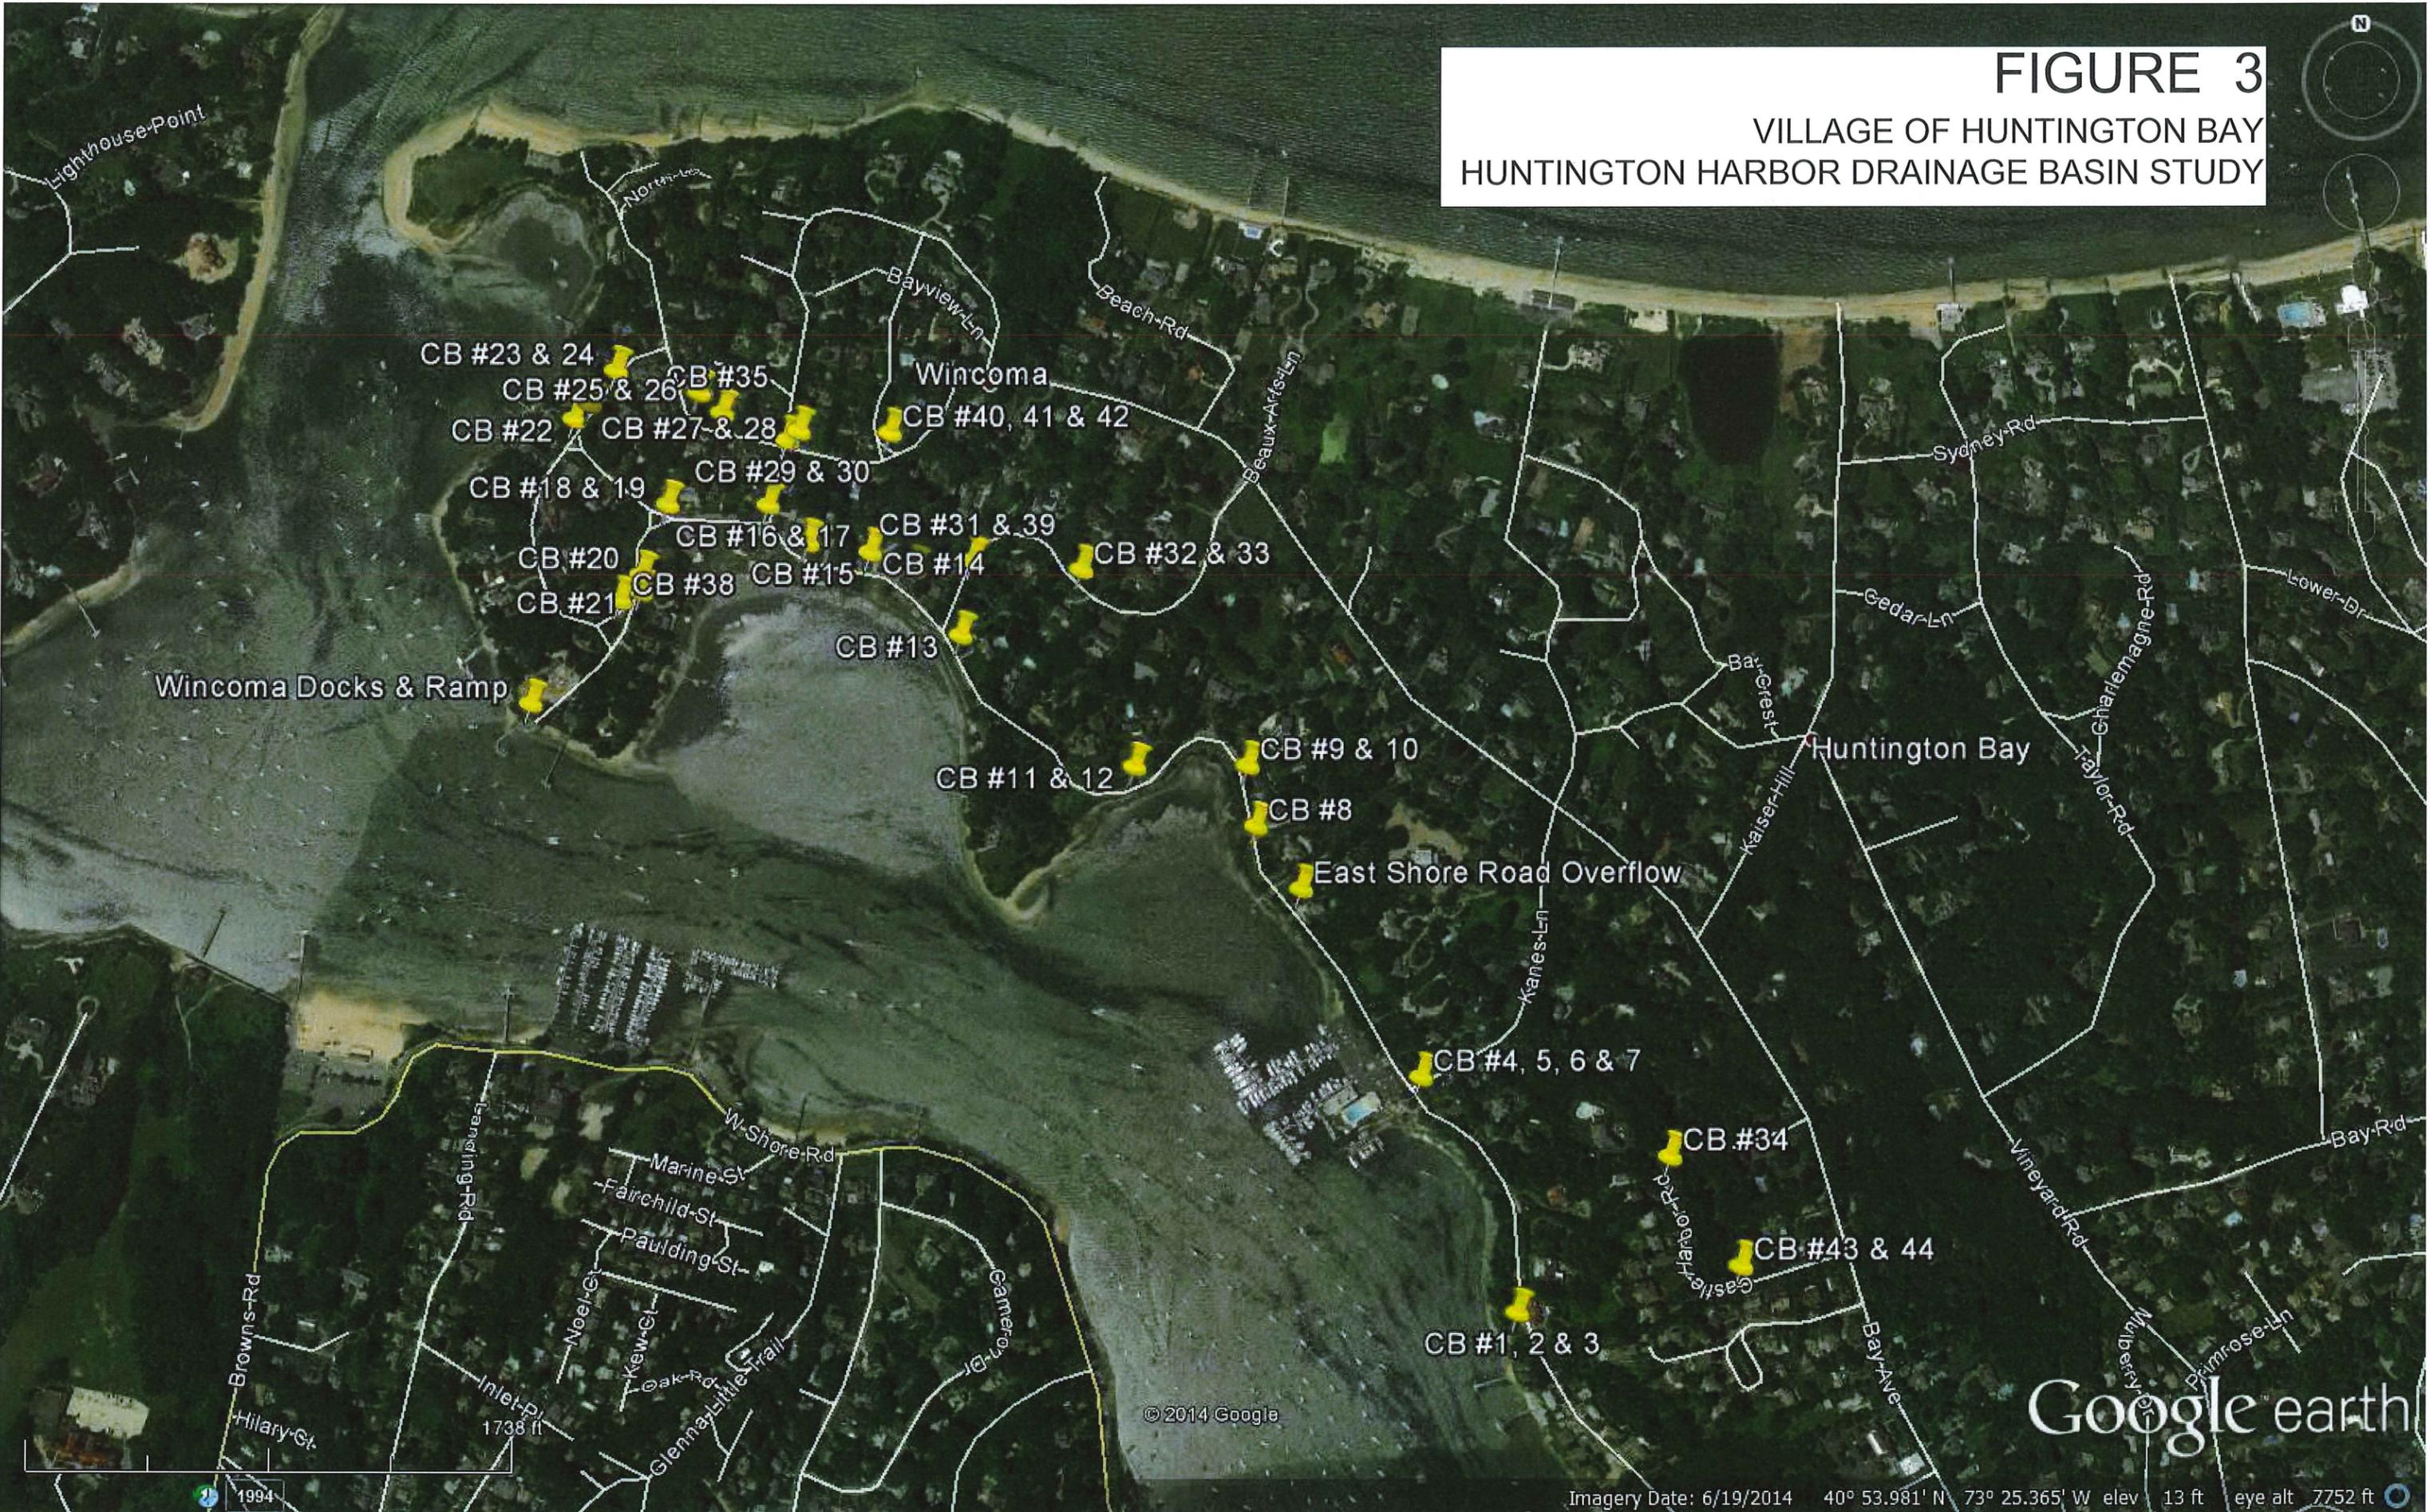
FIGURE 3
VILLAGE OF HUNTINGTON BAY
HUNTINGTON HARBOR DRAINAGE BASIN STUDY

CB #23 & 24
CB #25 & 26
CB #22
CB #18 & 19
CB #20
CB #21
CB #35
CB #27 & 28
CB #29 & 30
CB #16 & 17
CB #38
CB #15
CB #14
Wincoma
CB #40, 41 & 42
CB #31 & 39
CB #13

CB #11 & 12
CB #9 & 10
CB #8

Figure 3: Aerial Map
